Section 7 Results of Fieldwork

7.1 Results of Pedestrian Inspection

7.2 Test Excavation Results

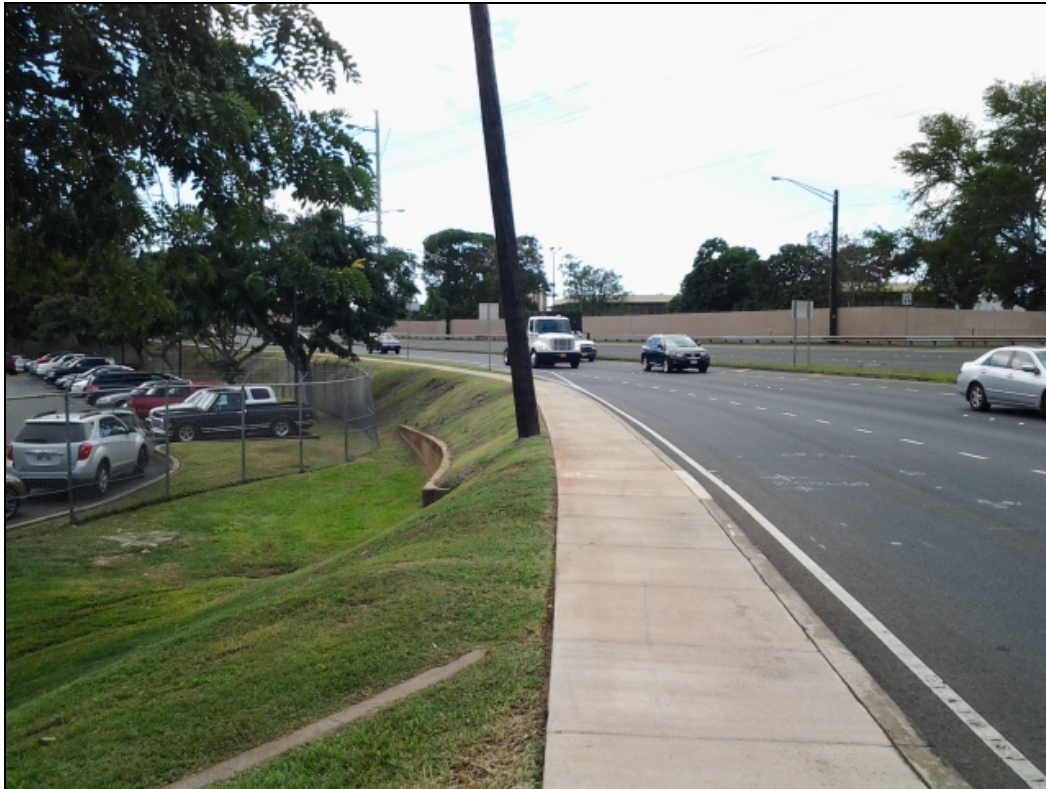
Figure 34. General view of T-003 (column foundation) vicinity on the east side of Kamehameha Highway, just south of Hālawā Drive, view to southwest

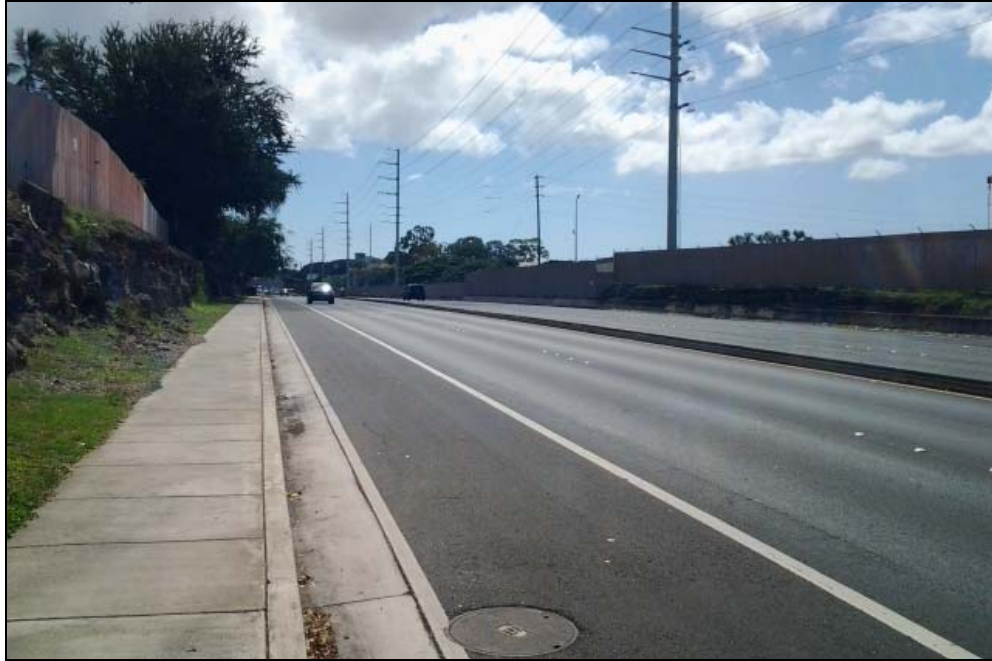
Figure 36. General view of road cut showing volcanic tuff ridges on both sides of Kamehameha Highway, looking towards T-005 (column foundation) location, view to south

Two significant fingers of rock land with little soil development (Figure 36 and Figure 37) bracket a small swale area of relatively fertile Hanalei silty clay (see Figure 5, Figure 38 & Figure 39) in the immediate vicinity of Kamehameha Highway and Radford Drive. The Pearl Harbor Naval Base Station lies in a “bay” of these fertile Hanalei silty clay soils between these rockland outcrop ridges.

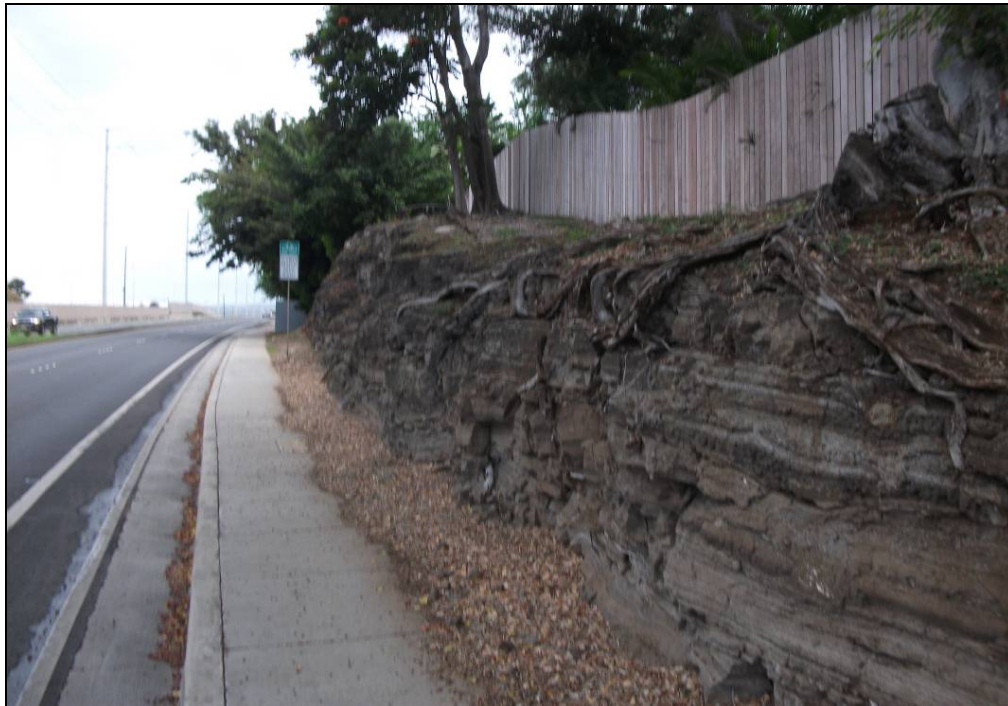
Figure 37. General view of Rock Land (rRK) on east side of Kamehameha Highway north of Radford Drive showing very thin overlying soil development, view to northeast

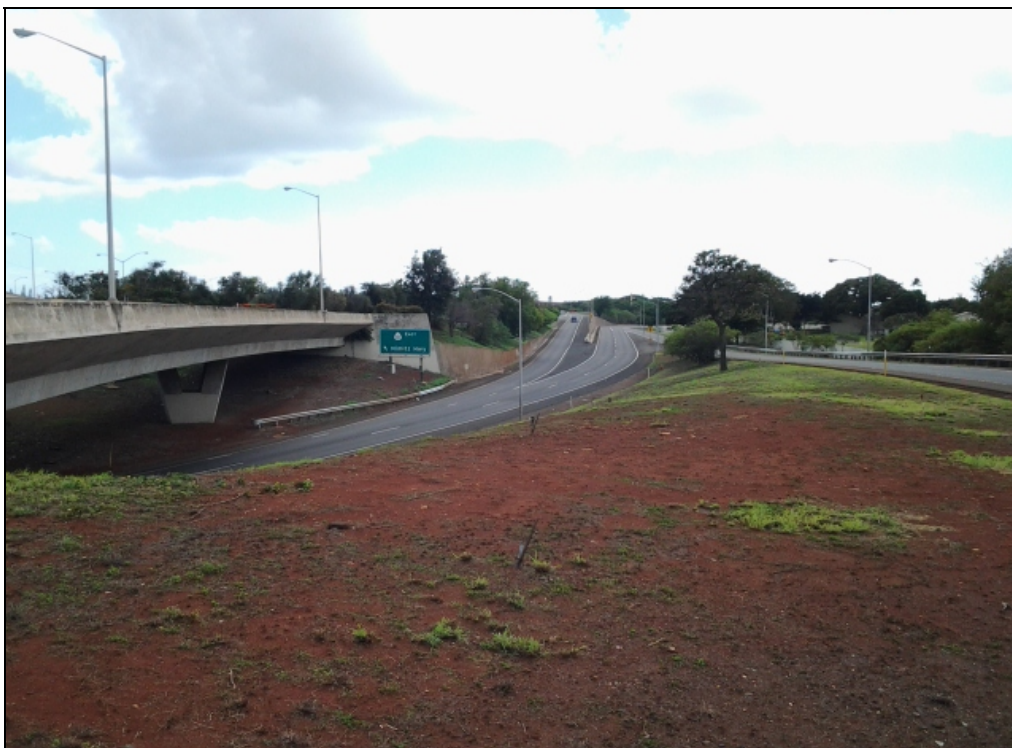
Figure 41. General view of rail alignment between T-013 (column foundation) and T-014 (column foundation), on west (*makai*) side of Makai Frontage Road, view to south

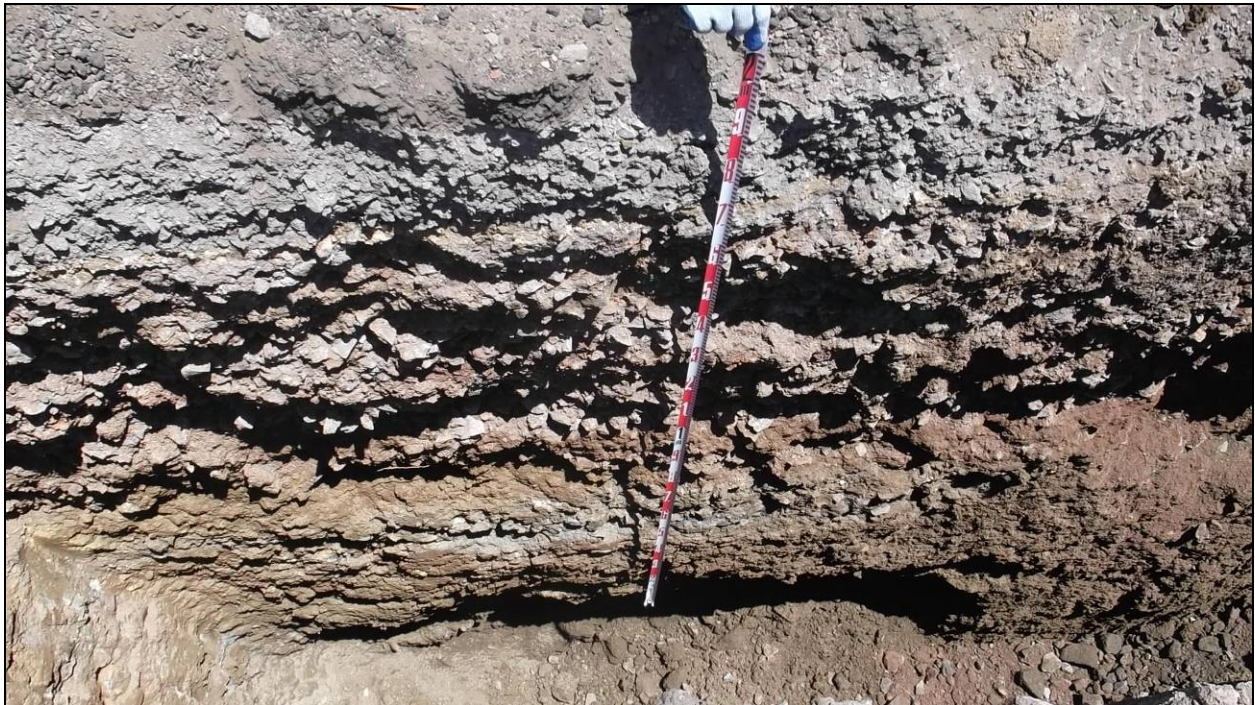
Figure 64. Photograph of Airport Section, T-001, general view of central portion of profile, view to east

Stratigraphic Summary: The stratigraphy, presented in Figure 64 and Figure 65, consisted of asphalt (Stratum Ia), basalt gravel base course (Stratum Ib), crushed coral fill (Stratum Ic), extremely gravelly silt fill (Stratum Id), gravelly clay loam fill (Stratum Ie), very cobbly loam fill (Stratum If), and locally-procured gravelly clay loam fill (Stratum Ig). All strata were fill material to the base of excavation at 295 cmbs, with Stratum Ig suggestive of locally procured material with boulders of local tuff. The stratigraphy was consistent with the USDA Fill Land (FL) designation.

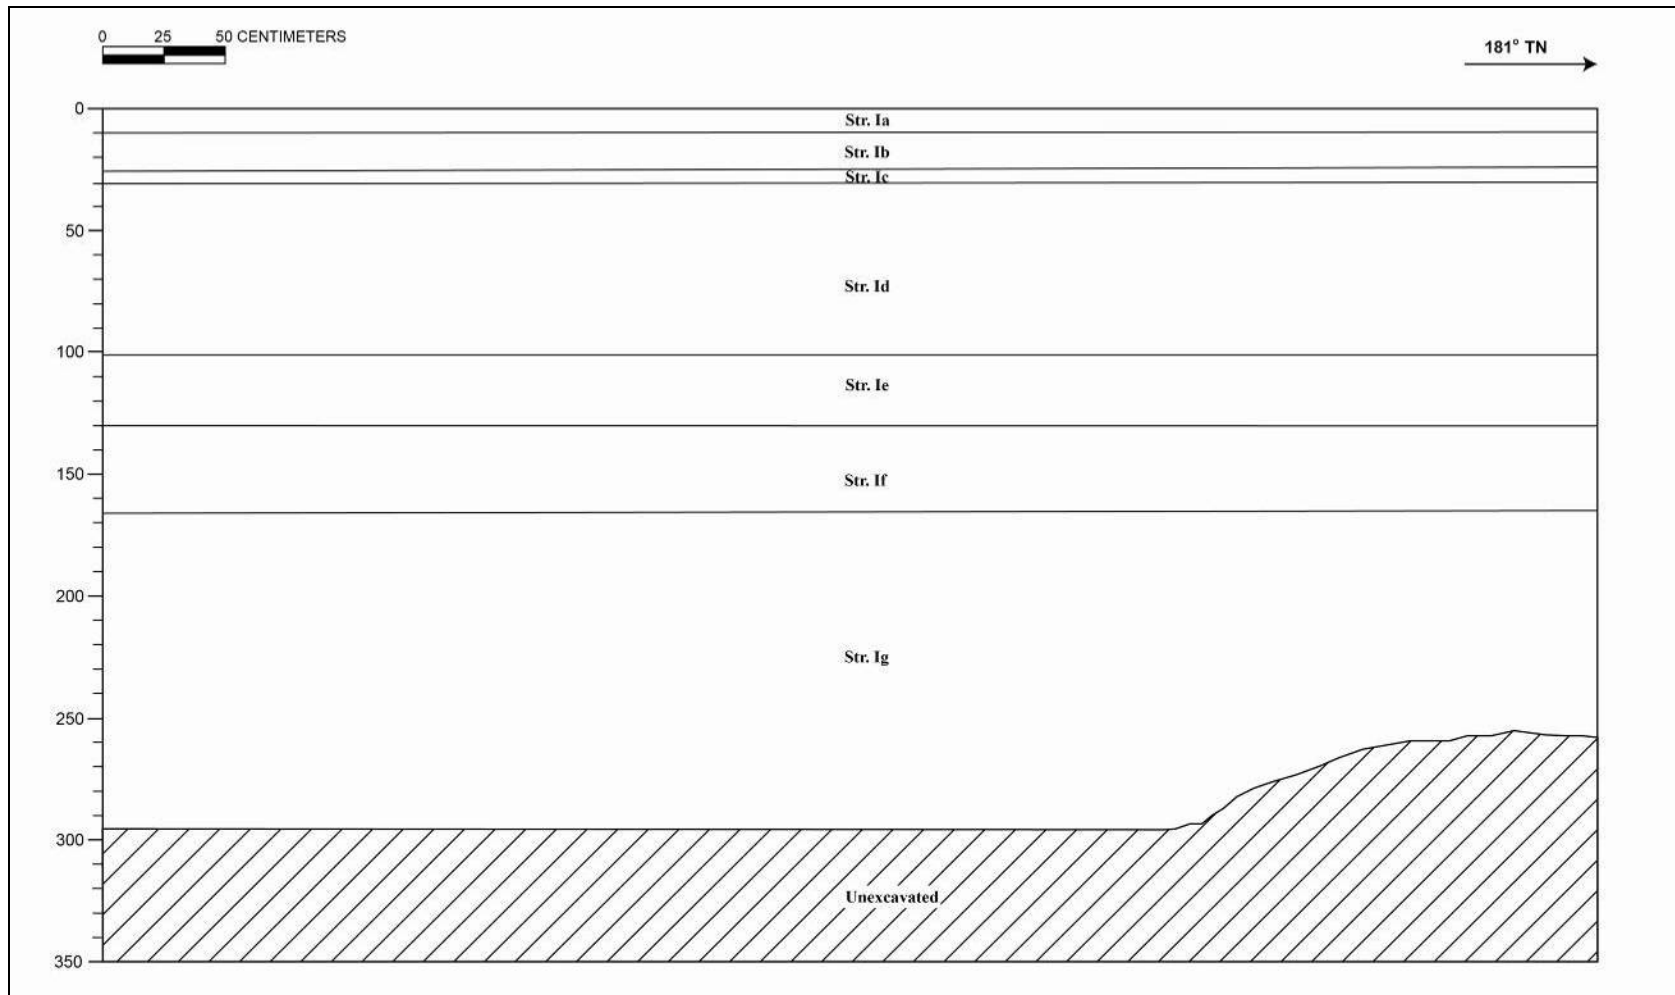
Figure 65. Airport Section, T-001 east profile (above) and stratigraphic description (below)

Stratum	Depth (cmbs)	Description
Ia	0-10	Asphalt
Ib	10-25	Fill; gravel; 10 YR 5/1 (gray); single-grain structure; dry, loose consistency; non-plastic; terrigenous origin; abrupt, smooth lower boundary; base course
Ic	25-30	Fill; extremely gravelly sand; 10 YR 4/4 (dark yellow brown); weak, fine, blocky structure; moist, very friable consistency; non-plastic; mixed origin; abrupt, smooth lower boundary; crushed coral base course
Id	30-100	Fill; extremely gravelly silt; 5 YR 3/4 (dark red brown); single-grain structure; moist, loose consistency; non-plastic; terrigenous origin; clear, smooth lower boundary; contains angular basalt gravel
Ie	100-130	Fill; gravelly clay loam; 10 YR 3/4 (dark yellow brown); weak, fine, crumb structure; moist, friable consistency; slightly plastic; terrigenous origin; clear, smooth lower boundary; contains angular basalt gravel
If	130-165	Fill; very cobbly loam; 10 YR 3/2 (very dark grayish brown); weak, fine, crumb structure; moist, very friable consistency; non-plastic; terrigenous origin; clear, smooth lower boundary; contains angular basalt cobbles

Ig	165-295	Fill; gravelly clay loam; 7.5 YR 4/3 (brown) with 30% small red mottles; weak, fine, crumb structure; moist, very friable consistency; slightly plastic; terrigenous origin; lower boundary not visible; contains both angular and water worn gravel to cobbles, few small boulders, (1) bivalve shell (collected); contains angular basalt gravel; locally-procured sediment used as fill

T-001 was excavated in close proximity to the previously placed P-38 series of pole locations (poles P38, P38A, P38b and P38c) monitored by Archaeological Consultants of Hawaii, Inc. (Avery et al. 1994:6). Near the mouth of Hālawā Stream the Avery et al (1994:24) study similarly documented multiple historic fill deposits down to sea level. The Avery et al. 1994 study and the present work support the conclusion of an International Archaeological Research Institute, Inc. archaeological resources survey for a Hālawā Bridge replacement project that: “20th century landscape modifications, including the presence of large quantities of fill material along the banks of [Hālawā] stream, several subterranean drainage pipes, and a concrete channel lining, have likely destroyed historic sites.” (Dye 1999: 4).

Historic evidence indicates substantial traditional Hawaiian activity in the vicinity of the mouth of Hālawā Stream. The thick fill deposits noted by Avery et al (1994:24) and Dye (1999: 4) again precluded documentation of any archaeological evidence of this activity.

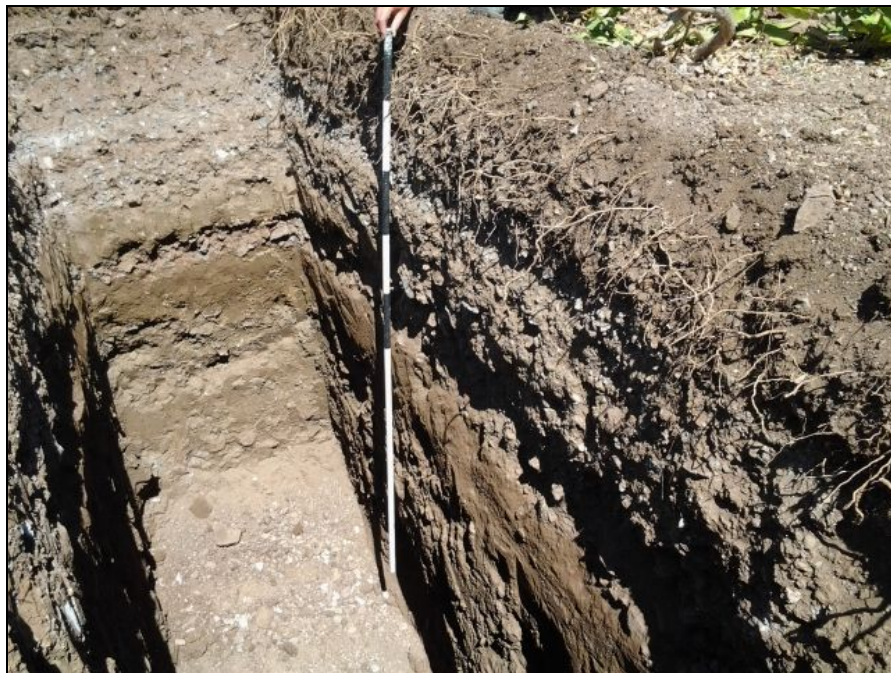
Figure 67. Photograph of Airport Section, T-002, general view of profile, view to southeast

Stratigraphic Summary: The stratigraphy, presented in Figure 67 and Figure 68, consisted of imported topsoil fill (Stratum Ia), coral gravel base course (Stratum Ib), extremely gravelly clay fill (Stratum Ic), and locally-procured clay fill (Stratum Id) overlying basalt bedrock. A cement cylinder and cement slab fragments were observed within Stratum Id between 210-240 cmbs.

The stratigraphy was consistent with the USDA soil survey designation of Fill Lands (FL). The test excavation was stopped in the northeast at 240 cmbs due to the presence of a large boulder. The south end was excavated to basalt bedrock at a depth of 280 cmbs.

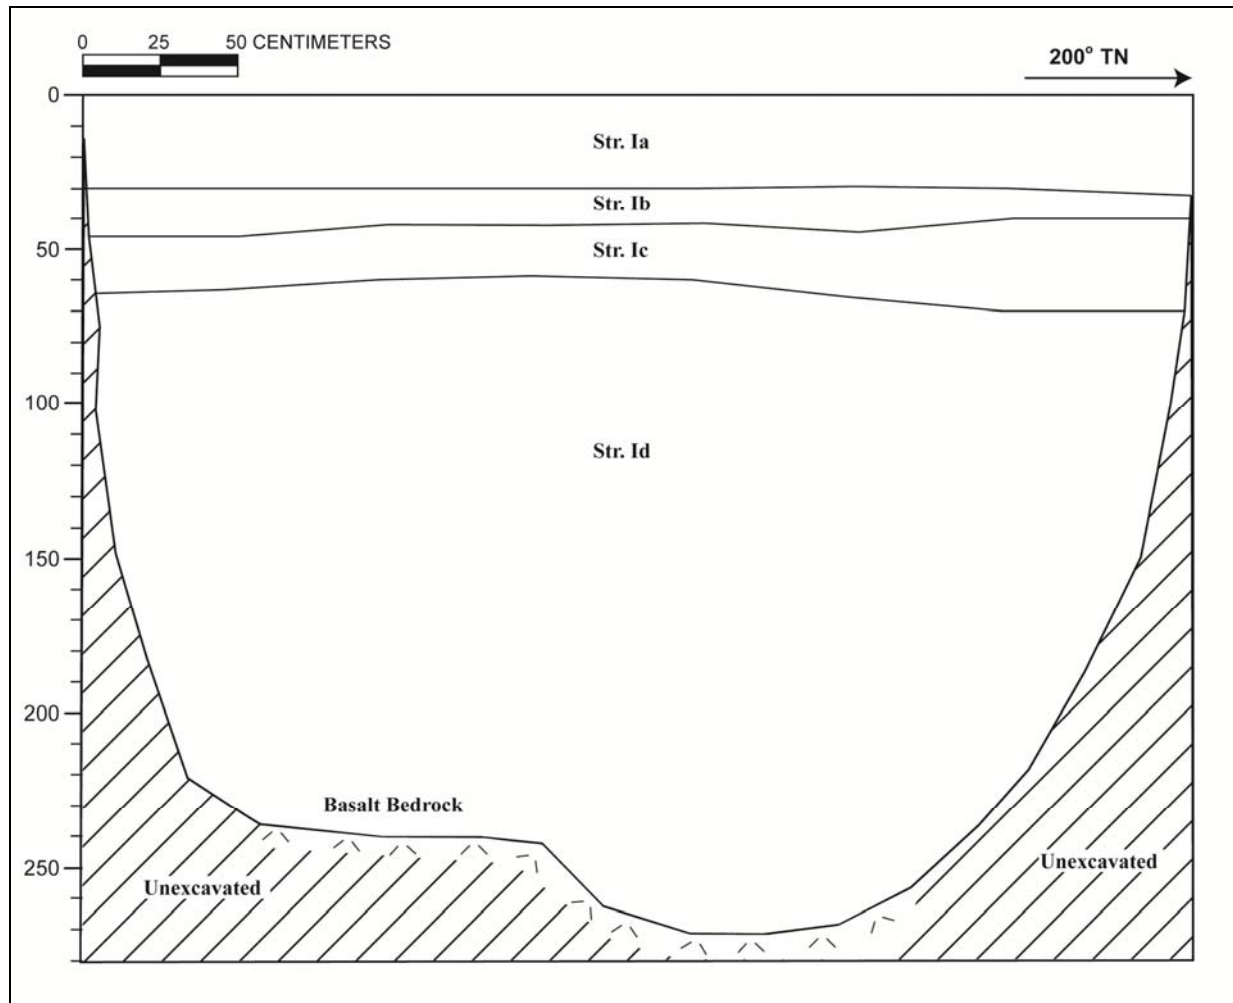
Figure 68. T-002 east profile (above) and stratigraphic description (below)

Stratum	Depth (cmbs)	Description
Ia	0-30	Fill; sandy silt loam; 10 YR 4/3 (brown); single-grain, fine structure; dry, loose consistency; non-plastic; terrigenous origin; clear, smooth lower boundary; many, medium, coarse roots; topsoil; landscape fill (modern)
Ib	30-40	Fill; 10 YR 5/1 (gray); extremely gravelly silty sand; single-grain, coarse structure; dry, loose consistency; non-plastic; terrigenous origin; clear, smooth lower boundary; few, fine, medium roots; coral gravel fill base course
Ic	40-60	Fill; extremely gravelly clay; 10 YR 4/4 (dark yellowish brown); single-grain, coarse structure; dry, weakly coherent consistency; slightly plastic; mixed origin; clear, smooth lower boundary; reworked alluvial silt loam with 60% coral and basalt cobbles and boulders
Id	60-275	Fill; clay; 10 YR 4/2 (dark grayish brown); single-grain, medium structure; moist, friable consistency; slightly-plastic; terrigenous origin; lower boundary not visible; locally procured fill with concrete debris

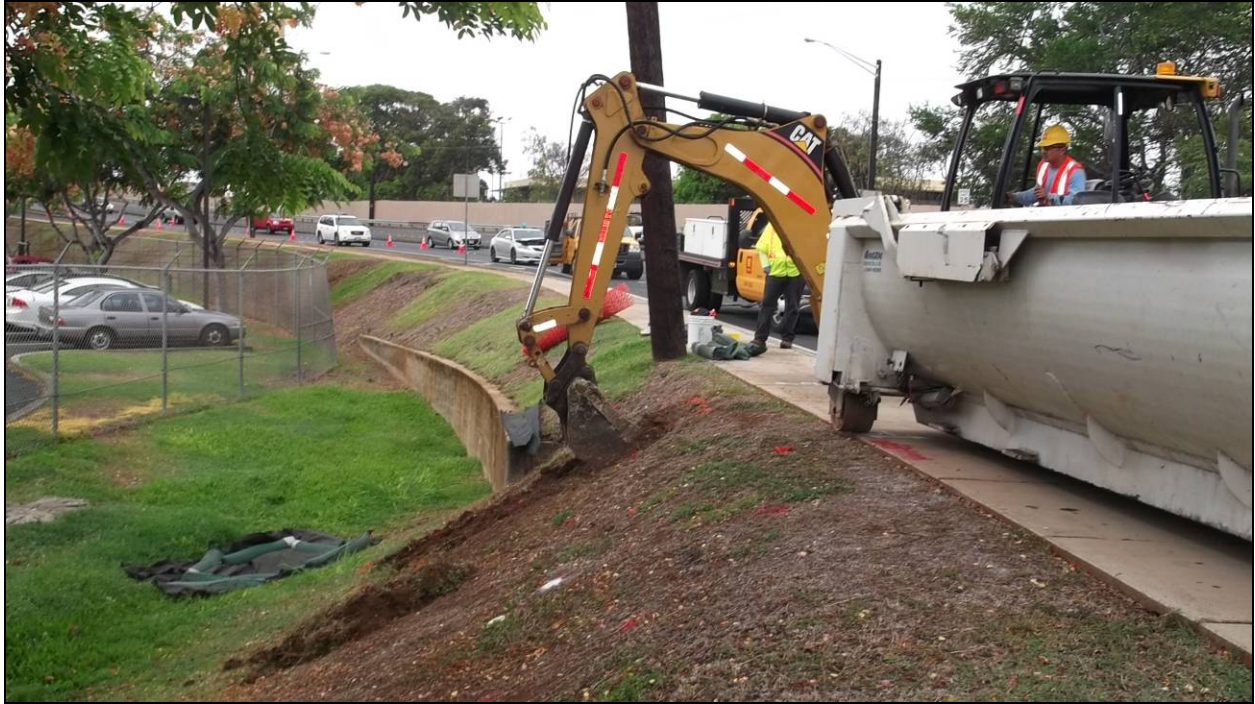
Figure 70. Photograph of Airport Section, T-003, general location, view to southwest

Summary: T-003 was located on the east slope of an approximately 2 m-high road causeway. Given the slope, safety concerns, and excavation logistics, it was decided to excavate into the lower portion of the road shoulder (see Figure 70). Fill sediment associated with the causeway included Stratum Ic and Id, which consisted of loose gravel (Ic) and boulders (Id). This loose fill sediment created unstable conditions that limited the length and depth of the excavation.

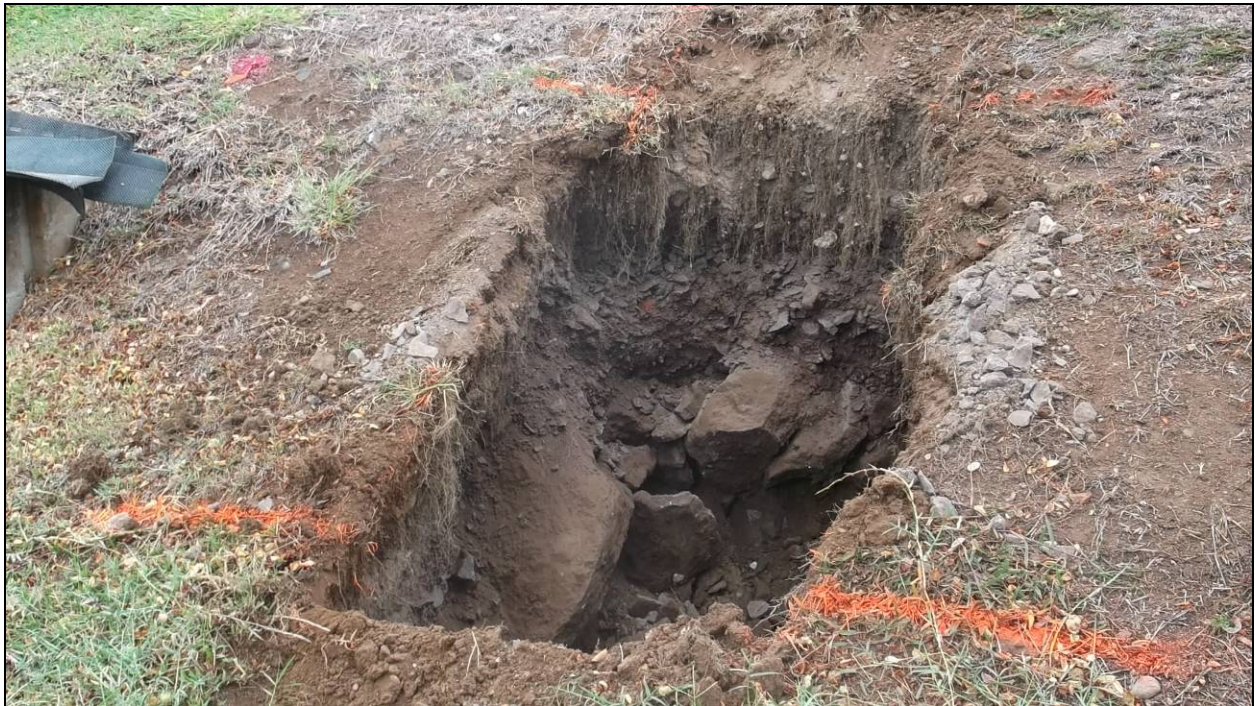
Figure 71. Photograph of Airport Section, T-003, general view of profile, view to west

Stratigraphic Summary: The stratigraphy, presented in Figure 71 and Figure 72, consisted of imported topsoil fill (Stratum Ia), gravelly sandy silt (Stratum Ib), extremely gravelly sand (Stratum Ic), extremely boulder sand (Stratum Id), natural clay loam alluvium with basalt boulders (Stratum II), and natural clay loam alluvium with decomposing coral and marine shell (Stratum III). The natural surface (Stratum II) was encountered at 130 cmbs.

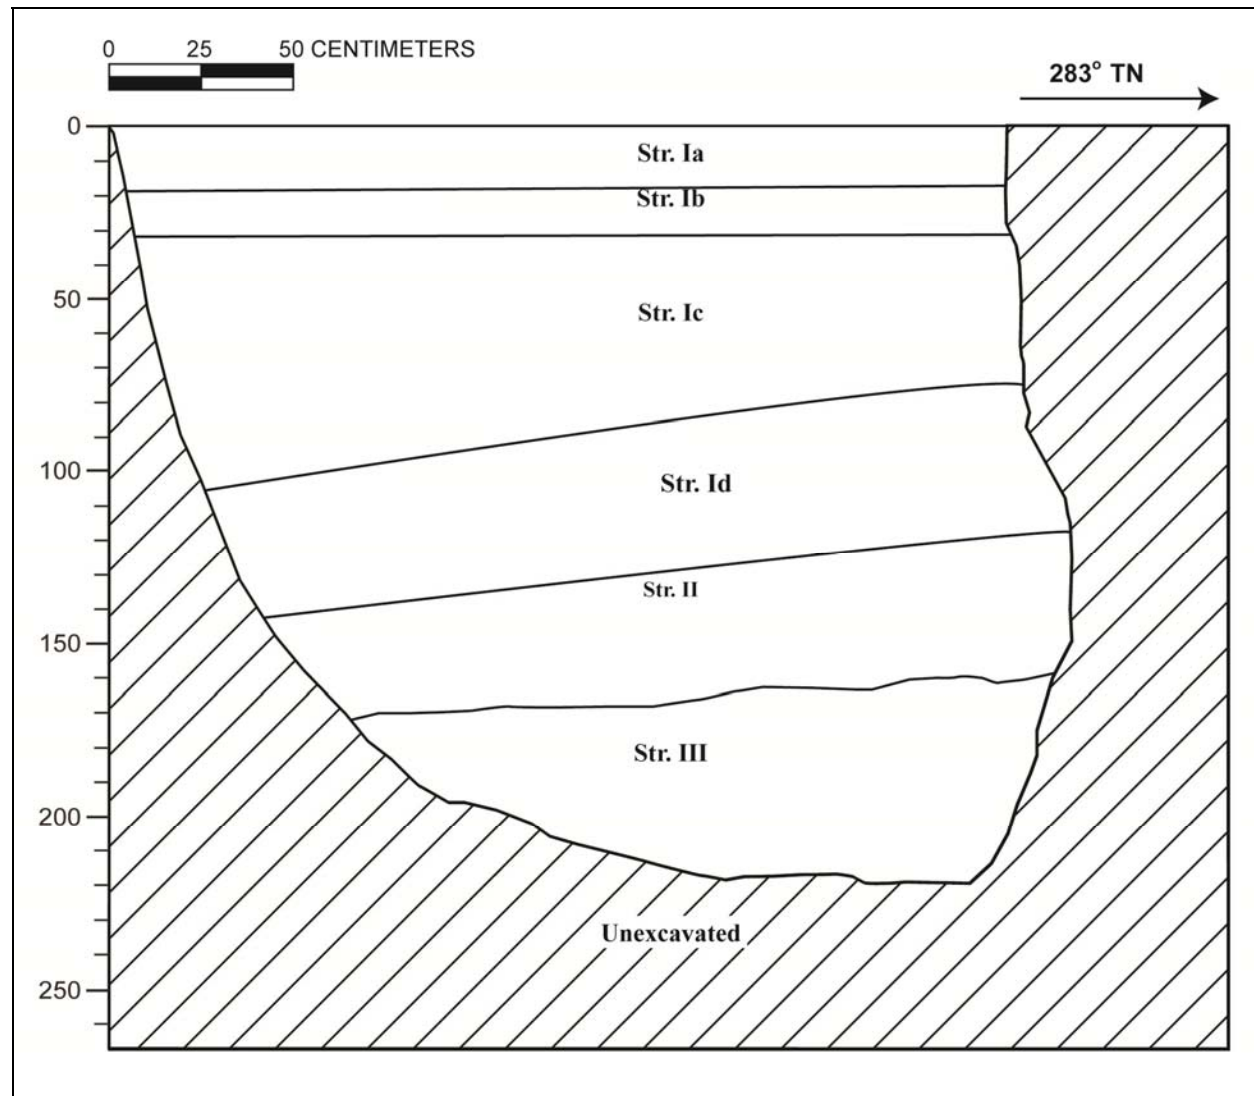
Figure 72. T-003 south profile (above) and stratigraphic description (below)

At roughly the level of the lower surrounding lands two strata of clay loam were observed that appeared to be homogenous alluvial deposits (Strata II and III). Stratum III contained a few pieces of decomposing coral and a bivalve shell, which is consistent with natural sediment inclusions in this region of previous mudflats at the edge of Pearl Harbor and Loko Kunana. No cultural resources were observed.

Stratum	Depth (cmbs)	Description
Ia	0-17	Topsoil; silt loam; 10 YR 3/6 (dark yellowish brown); weak, fine, crumb structure; moist, friable consistency; non-plastic; terrigenous origin; clear; smooth lower boundary; many, very fine to fine roots; topsoil
Ib	17-30	Fill; gravelly sandy silt; 10 YR 5/2 (brown) with mottles (50%) (pale brown); single-grain structure; moist, loose consistency; non-plastic; marine origin; abrupt, smooth lower boundary; common, very fine to fine roots
Ic	30-75	Fill; extremely gravelly sand; single-grain structure; dry, loose consistency; non-plastic; terrigenous origin; clear, smooth lower boundary; few, very fine roots; basalt gravel fill beneath sidewalk and road causeway
Id	75-130	Fill; extremely boulder sand; single-grain structure; dry, loose consistency; terrigenous origin; abrupt lower boundary; basalt boulder fill beneath roadway and causeway
II	130-160	Natural; clay loam; 10 YR 4/3 (brown); medium structure; moist, friable consistency; plastic; terrigenous origin; clear to diffuse, smooth lower boundary; few, fine, medium roots; contains some angular basalt gravels; likely natural alluvium; appeared homogenous

III	160-195	Natural; clay loam; 10 YR 3/2 (very dark grayish brown); moderate, fine, medium, blocky structure; moist, firm consistency; plastic; terrigenous origin; lower boundary not visible; contains some decomposing coral and (1) bivalve shell (not collected due to excavation instability)

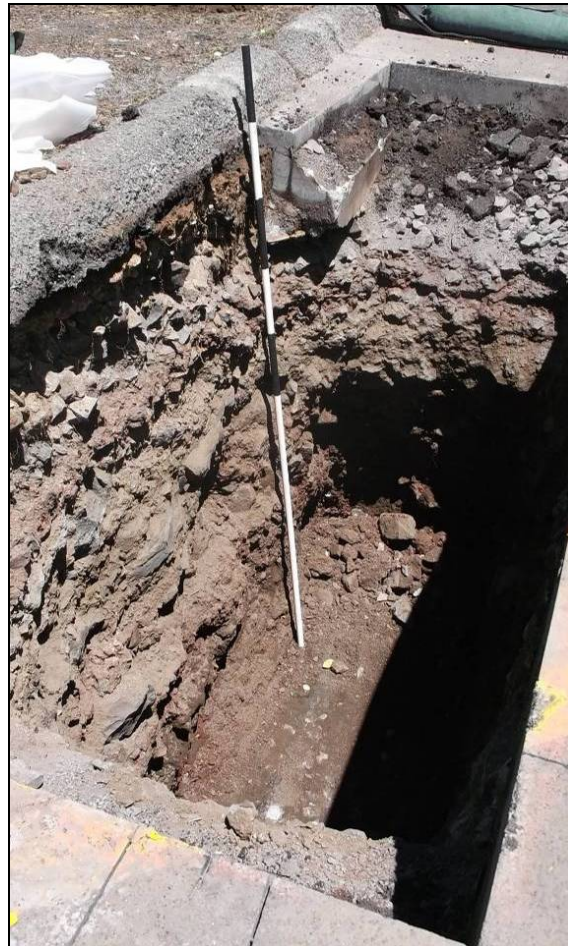
Figure 74. Photograph of Airport Section, T-004, general view of profile, view to northwest

Stratigraphic Summary: The stratigraphy, presented in Figure 74 and Figure 75, consisted of asphalt (Stratum Ia) basalt gravel base course (Stratum Ib), and very gravelly loam fill (Stratum Ic) overlying natural basalt bedrock (Stratum II). The USDA soil survey Fill land (FL) designation for this location was determined to be accurate.

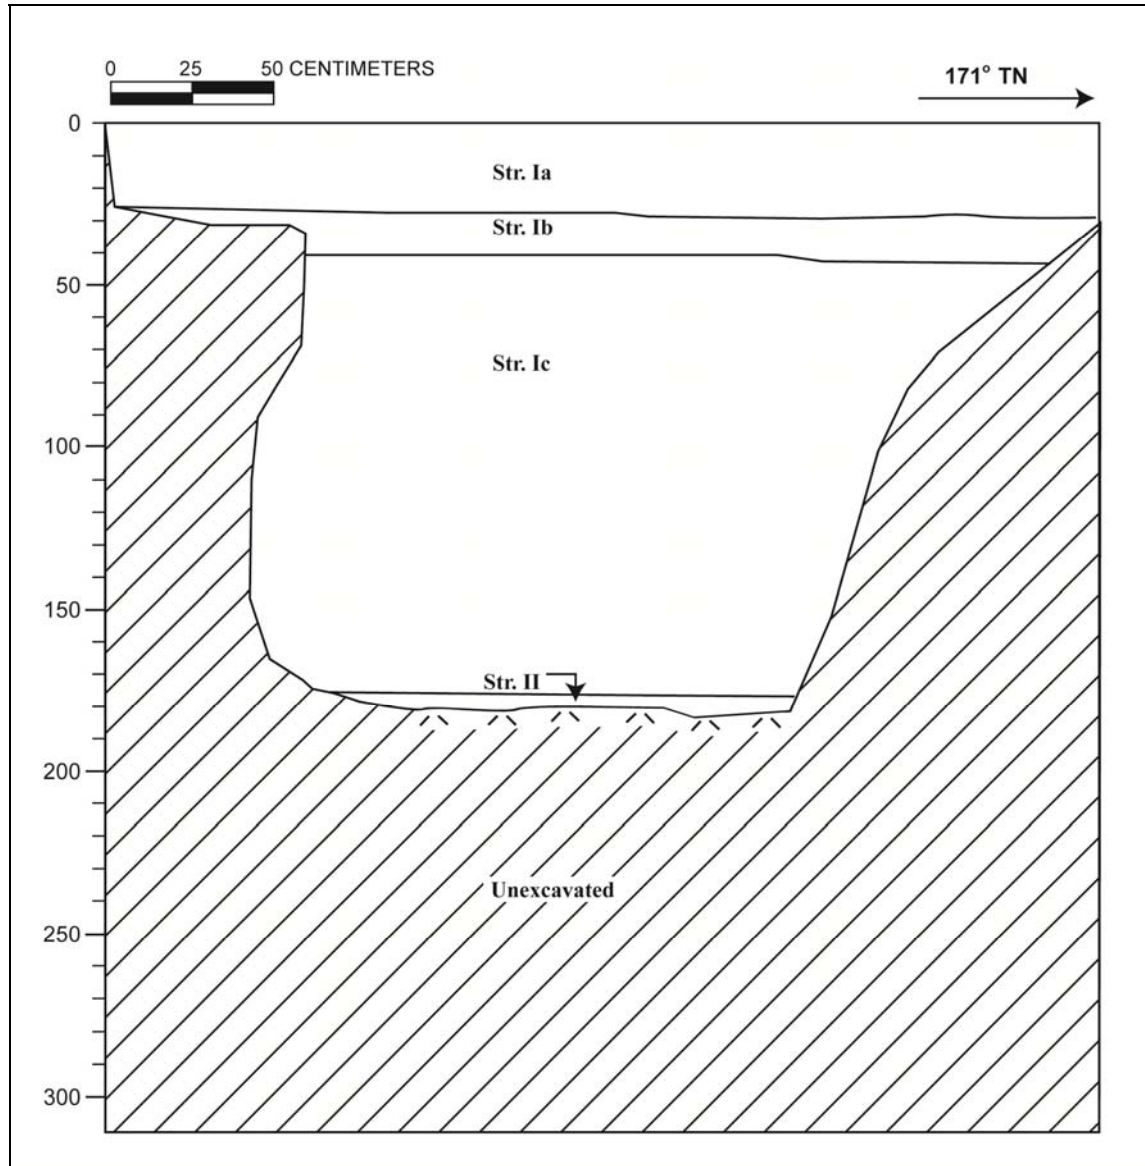
Stratum	Depth (cmbs)	Description
Ia	0-25	Asphalt
Ib	25-40	Fill; extremely gravelly sand; 10 YR 5/1 (gray); structureless, single-grain; moist, loose consistency; very abrupt lower boundary; basalt gravel base course
Ic	40-180	Fill; very gravelly loam; 10 YR 3/3 (dark brown); weak, crumb structure; moist, friable consistency; slightly plastic
II	180-185	Natural; basalt bedrock; 10 YR 5/1 (gray); lower boundary not visible

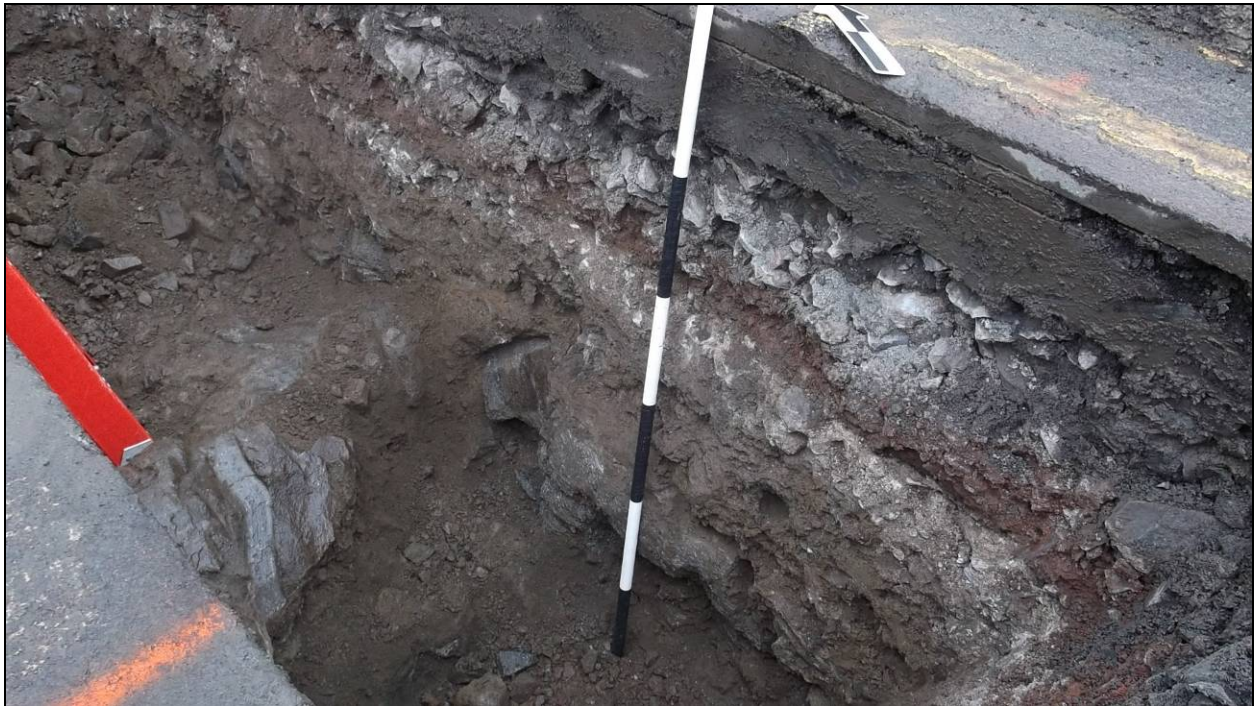
Figure 80. Photograph of Airport Section, T-005, general view of profile, view to northeast

Stratigraphic Summary: The stratigraphy, presented in Figure 80 and Figure 81, consisted of asphalt (Stratum Ia), basalt gravel base course (Stratum Ib), gravelly clay loam fill (Stratum Ic), and very gravelly sand fill (Stratum Id) overlying natural extremely gravelly loam (Stratum II) and volcanic tuff bedrock (Stratum III).

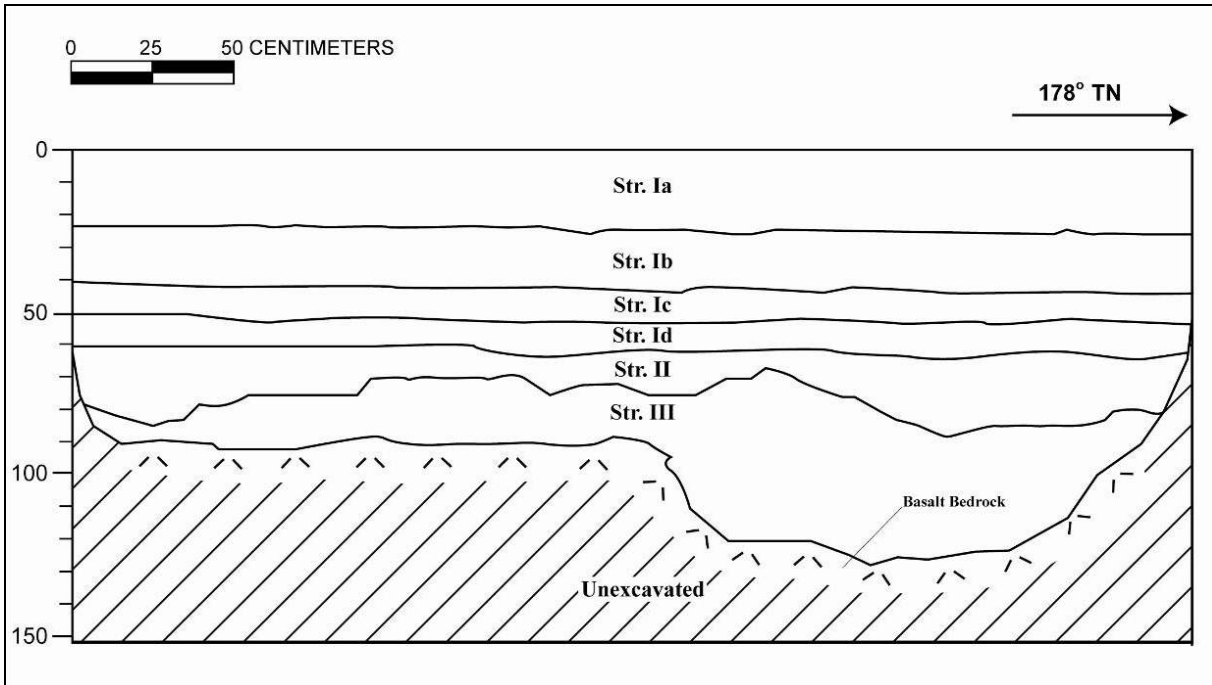
Stratum	Depth (cmbs)	Description
Ia	0-22	Asphalt
Ib	20-40	Fill; extremely gravelly sand; 10 YR 6/1 (gray); single-grain, fine structure; moist, loose consistency; non-plastic; terrigenous origin; abrupt, smooth lower boundary; basalt gravel base course
Ic	40-50	Fill; gravelly clay loam; 7.5 3/3 (dark brown); weak, fine, crumb structure; moist, friable consistency; slightly plastic; mixed origin; abrupt, smooth lower boundary; imported fill material associated with grading and leveling for road
Id	50-60	Fill; very gravelly coarse sand; 10 YR 8/2 (very pale brown) with mottles (50%, very coarse) of 10 YR 6/1 (gray); single-grain structure; moist, loose consistency; non-plastic; mixed origin; abrupt, smooth lower boundary; basalt and coral gravels in coarse sand matrix
II	60-85	Natural; extremely gravelly loam; 10 YR 3/2 (very dark gray brown); weak, medium, crumb structure; moist, friable consistency; slightly plastic; terrigenous origin; abrupt, wavy lower boundary; natural colluvial sediment truncated during cutting and bulldozing for modern road surface

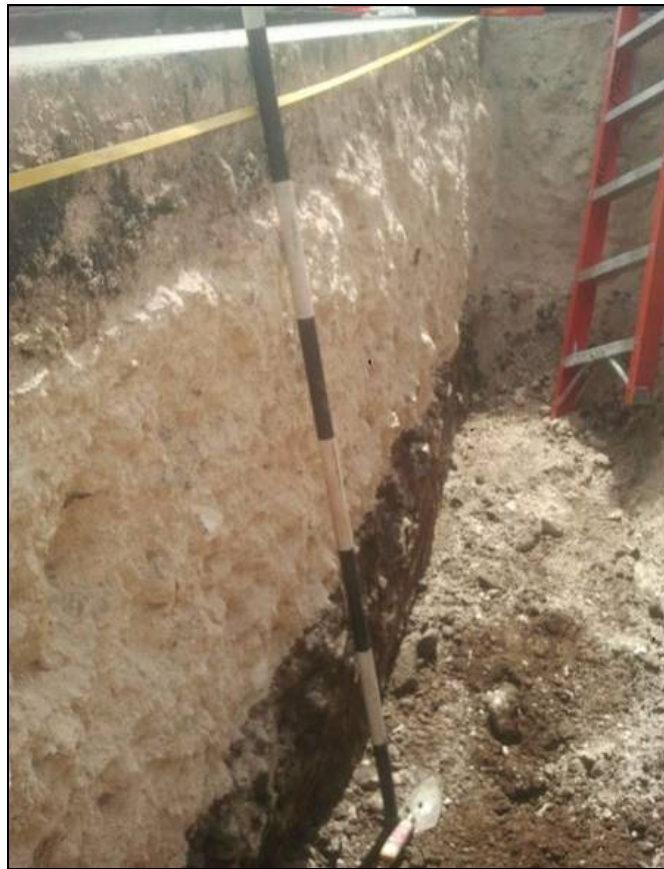
Figure 84. Photograph of Airport Section, T-006, general view of profile, view to southeast

Stratigraphic Summary: The stratigraphy, presented in Figure 84 and Figure 85, consisted of asphalt (Stratum Ia), very gravelly to cobbly crushed coral fill (Stratum Ib), and natural very cobbly clay loam (Stratum II). Survey results did not conform to the USDA soil designation of Hanalei silty clay (HnB). The presence of a large quantity of water-rounded basalt cobbles within the upper and lower boundaries of Stratum II may be indicative of high energy alluvial deposition.

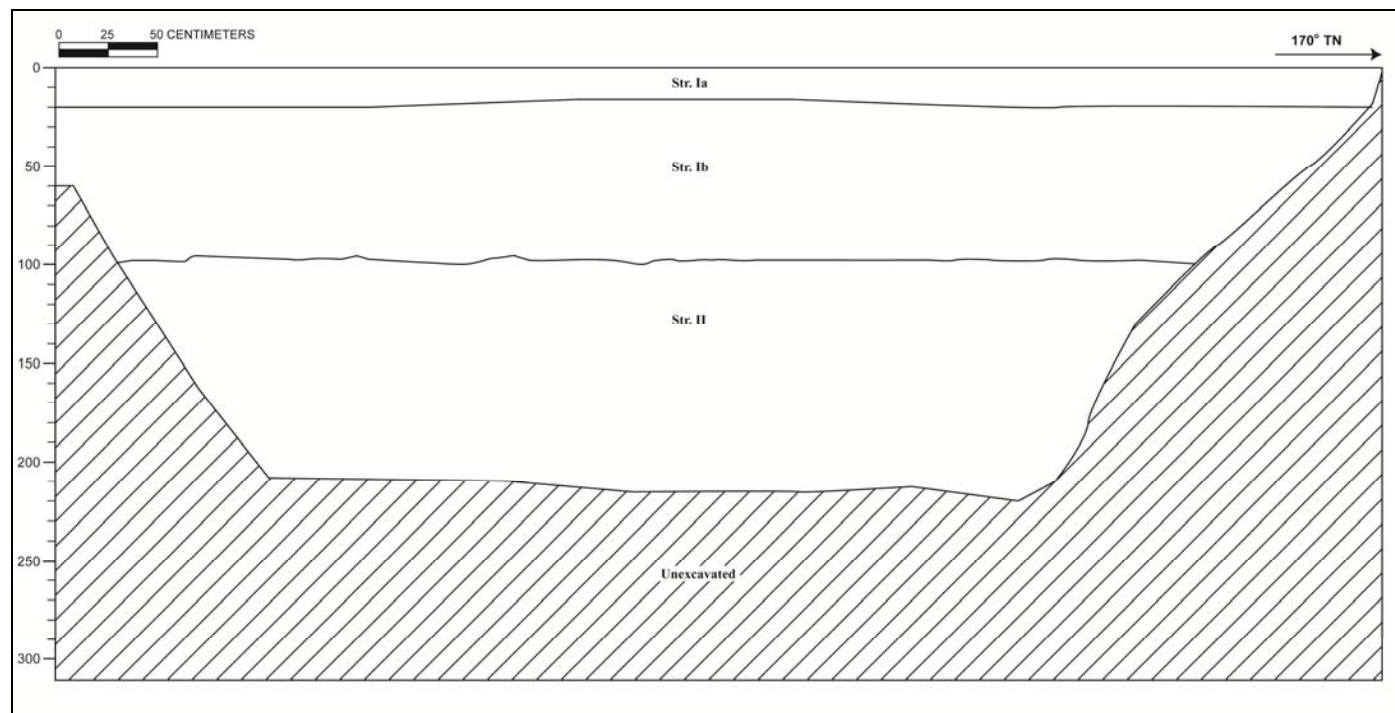
Summary: A thick layer of asphalt (Stratum Ia) was excavated through and a thick layer of crushed coral fill (Stratum Ib) was observed. Below the crushed coral fill was a thick layer of very cobbly clay loam (Stratum II) natural sediment. The presence of a large quantity of water-rounded basalt cobbles within the upper and lower boundaries of the natural sediment indicated evidence of high energy alluvial deposition. A bulk sample of the natural sediment was collected, and a portion of the sample was submitted for pollen analysis. The results of this analysis are presented in Results of Laboratory Analysis, Section 8.3. Instability of the sidewalls effectively ended further excavation of T-006 at 212 cmbs. No cultural resources were observed.

Stratum	Depth (cmbs)	Description
Ia	0-19	Asphalt
Ib	19-100	Fill; very gravelly to cobbly sand; 2.5 Y 8/2 (pale brown); structureless; dry, loose consistency; non-plastic; marine origin; abrupt, smooth lower boundary; crushed coral base course
II	95-212	Natural; very cobbly clay loam; 7.5 YR 2.5/3 (very dark brown); single-grain, weak, medium, blocky structure; dry, hard consistency; plastic; terrigenous origin; lower boundary not visible; contains one unidentified marine shell and sea urchin at 162-175 cmbs

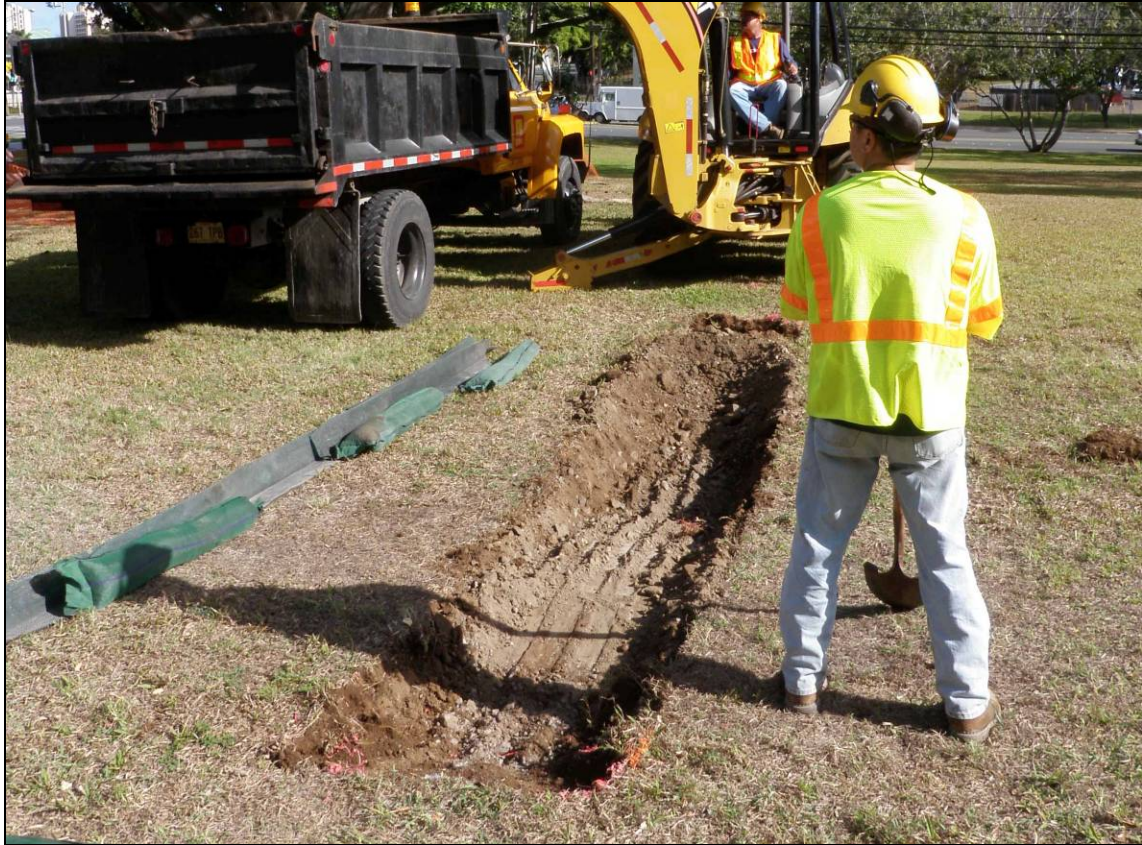
Figure 91. Photograph of Airport Section, T-008, general location, Radford Drive in background, view to north

Summary: Stratigraphy present within T-008 consisted of grass sod (Stratum Ia) and coral fill (Stratum Ib) overlying decomposed basalt bedrock (Stratum IIa) and solid basalt bedrock (Stratum IIb). The underlying solid bedrock appears to be descending to the north as it extends from the rock ledge to the south. No cultural resources were encountered.

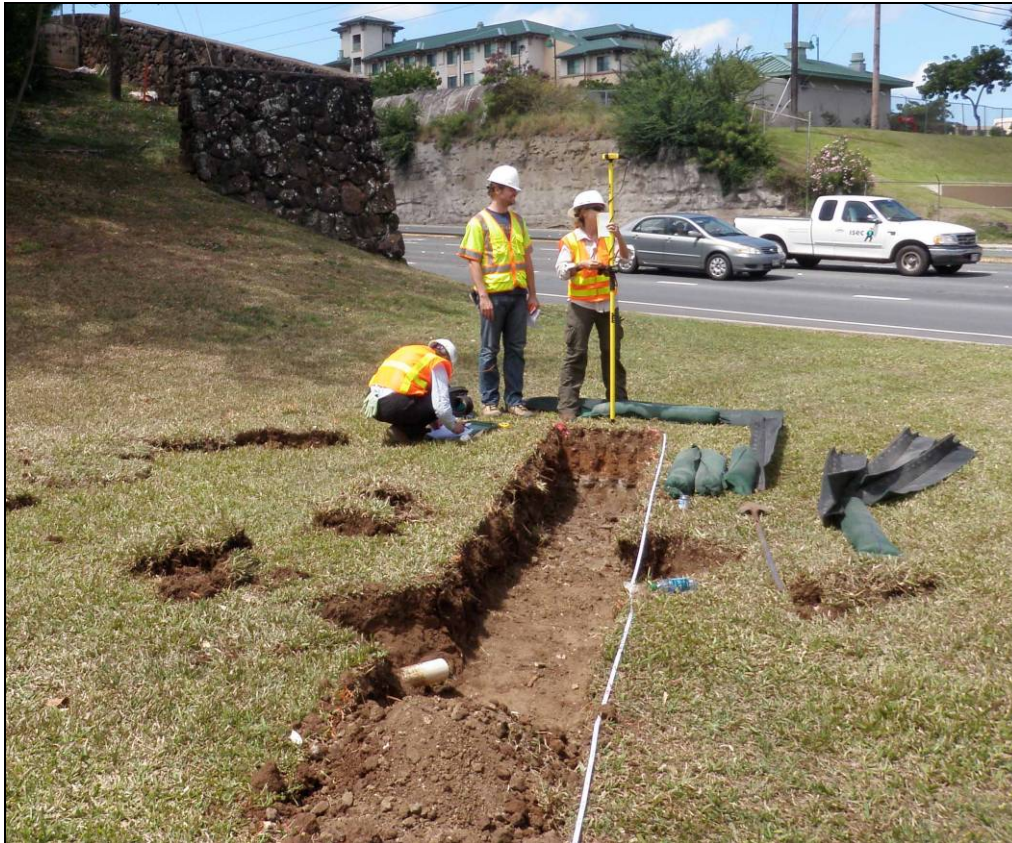
Figure 94. Photograph of Airport Section, T-009, general location, view to southwest

Summary: The stratigraphy consisted of fill (Stratum Ia and Ib) overlying decomposing bedrock (Stratum II). The only cultural material found consisted of a few glass fragments in Stratum Ia and Ib and an abandoned PVC waterline pipe in Stratum Ib. No cultural resources were identified.

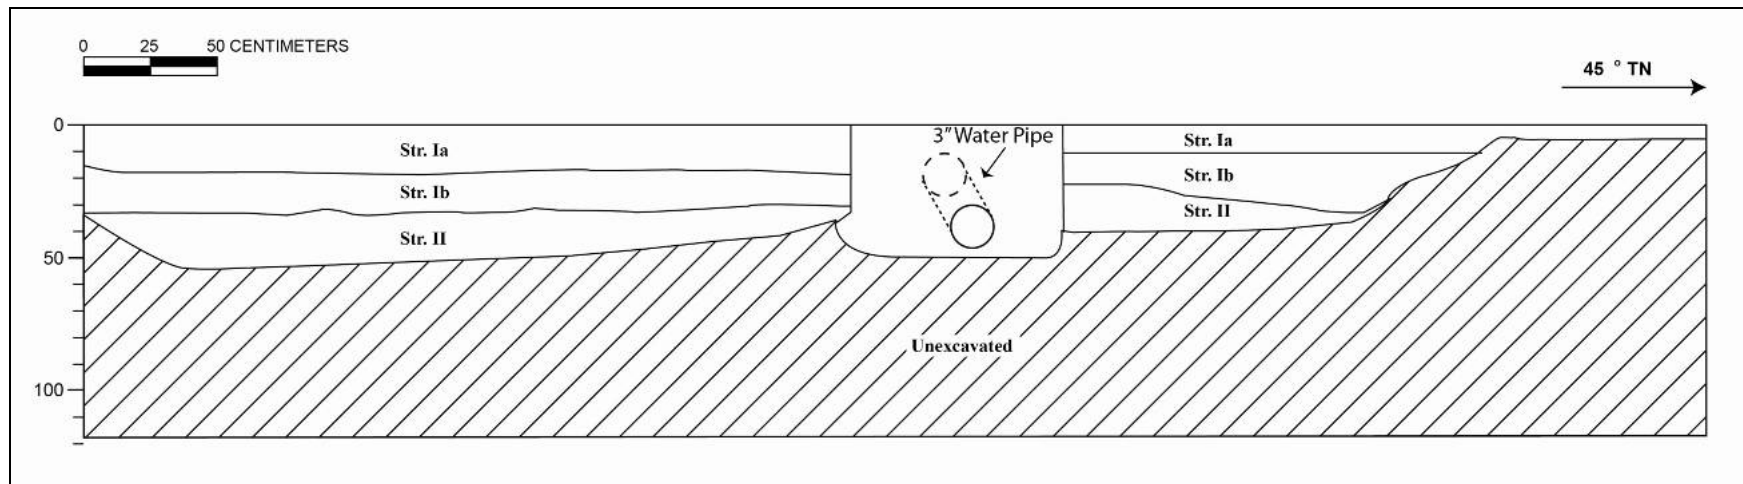
Stratum	Depth (cmbs)	Description
Ia	0-17	Fill; loam; 7.5 YR 3/4 (dark brown); weak, fine, crumb structure; moist, very friable consistency; non plastic; terrigenous origin; clear, smooth lower boundary; many, very fine to fine roots; imported fill with grass
Ib	15-31	Fill; clay loam; 2.5 YR 3/4 (dark reddish brown); weak, fine, crumb structure; moist, very friable consistency; slightly plastic; clear, smooth lower boundary; common, very fine to fine roots; imported fill likely used for leveling former land surface
II	31-50	Natural; decomposing bedrock; 2.5 YR 5/3 (light olive brown); very gravelly, weak, fine, crumb structure; hard consistency; non-plastic; terrigenous origin; lower boundary not visible; deposit consisting of very gravelly decomposing natural tuff
